Support of LAVA Testing and Integration Phase

LAVA Integration and Testing Summer Session

Date: 08 / 08 / 2014

Support of LAVA Integration and Testing

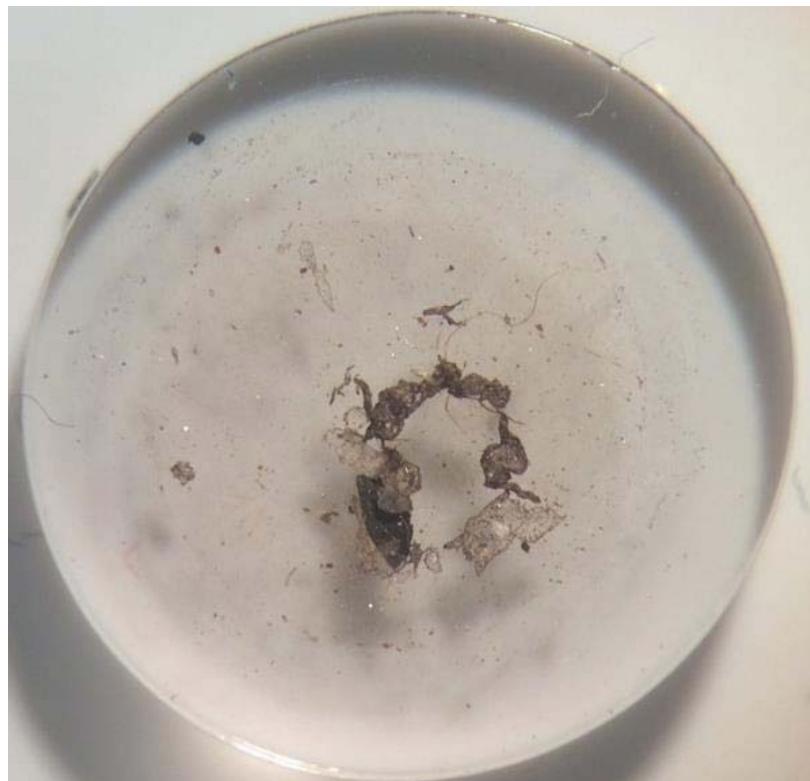
appeared to be deposited onto the bottom sapphire window internally to the surge tank. The bottom window was removed and photographs were taken. The bottom sapphire window was sent to the NASA Chemistry Lab to identify the residue on the window. The window was examined by optical microscopy and further analyzed by Fourier transform infrared spectroscopy³.

After removing the bottom sapphire window, debris was found on the internal surge tank side of the sapphire window. The debris found on the sapphire window can be seen in Figure 6. Also, a thin clear layer, not easily visible in Figure 6, appeared to be deposited onto the sapphire window. Optical microscopy showed the windows had a coating associated with a large amount of fine particles and fibers. Fourier transform infrared spectroscopy identified silicone associated with carbonate. Scanning electron microscopy showed a significant amount of skin cells which was consistent with the amount of biological salts. The large deposit was determined to be polytetrafluoroethylene, associated with silicone oil, and 100's of metal particles³.

Figure 6. Material deposited on bottom sapphire window

The material deposited on the sapphire window is believed to be blocking the path of light between the emitter and the detector. The deposited film and material is one factor leading to the loss in counts seen between February and June.

Further investigation can be done to determine exactly where the material that deposited on the sapphire window originated from and solutions to reducing its accumulation should be explored should it be a material native to the system. Also, the new collimators should be tested with the clean sapphire windows to establish a baseline for how the alignment in the surge tank impacts the counts. Finally, NIRST is a complex instrument with multiple failure points; moving forward the team will need to consider whether the benefits to science from having NIRST including in the instrument suite is worth the risk presented by the multiple failure points and increased mass.
